Restoration of Load-Bearing Timber Members Subjected to Fungal Growth: A Case Study of Louhisaari Manor's Roof Truss Structure

Master's thesis submitted for evaluation in order to finalize master's degree in Building Technology.

Espoo, 21st of September, 2019

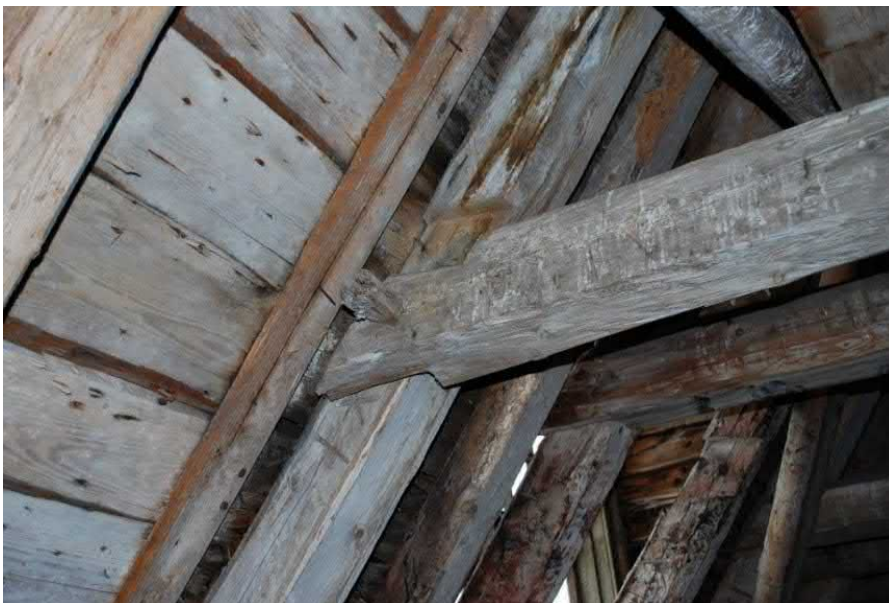
Figure 34. Connection that has lost its structural capacity. Original markings can be seen on the side of the rafter. Also, one collar beam is entirely missing from its place which can be due to obstacles in between the rafter pairs. See detail C in Figure 18.

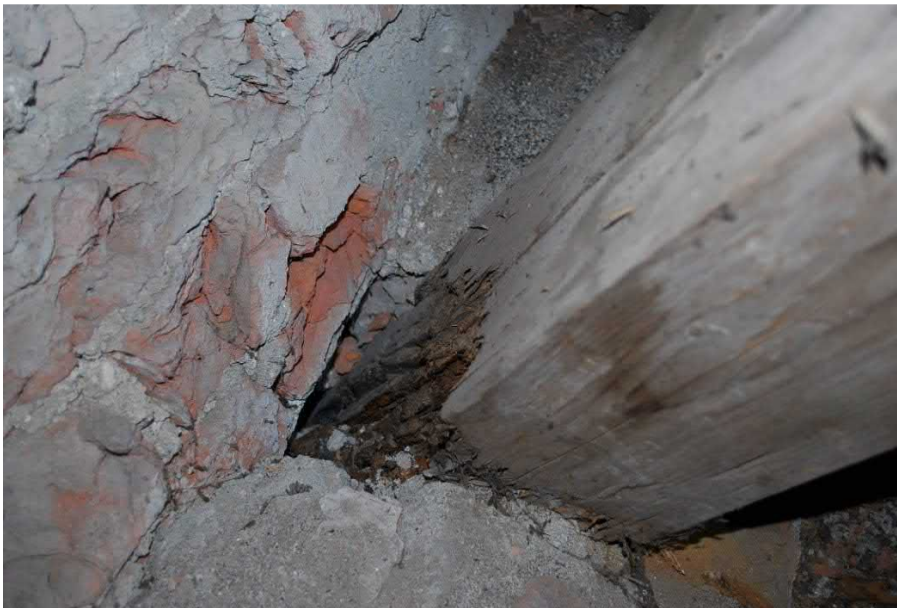
Figure 35. Rotten rafter S29 penetrating to the masonry wall.

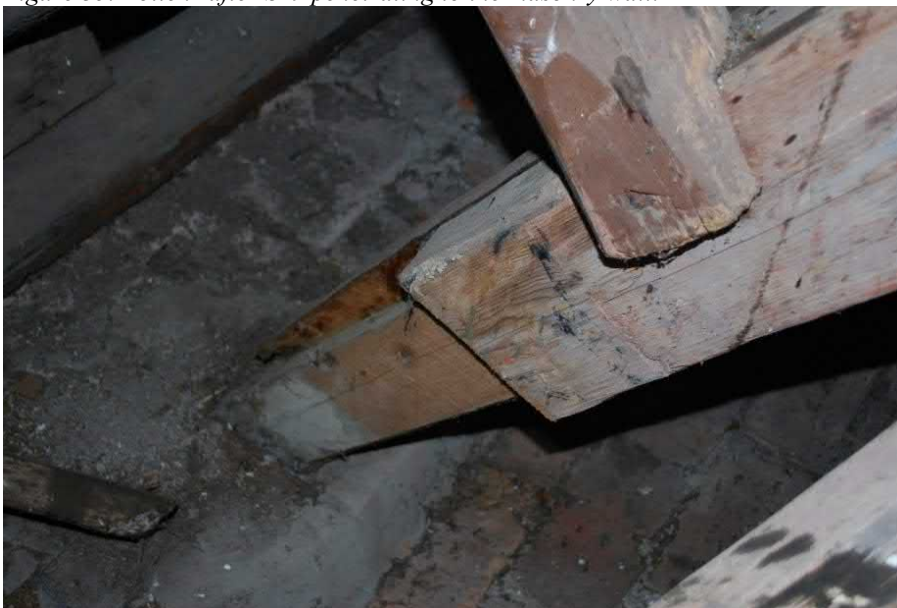
Figure 36. Previous repair intervention on the end of the rafter S43.

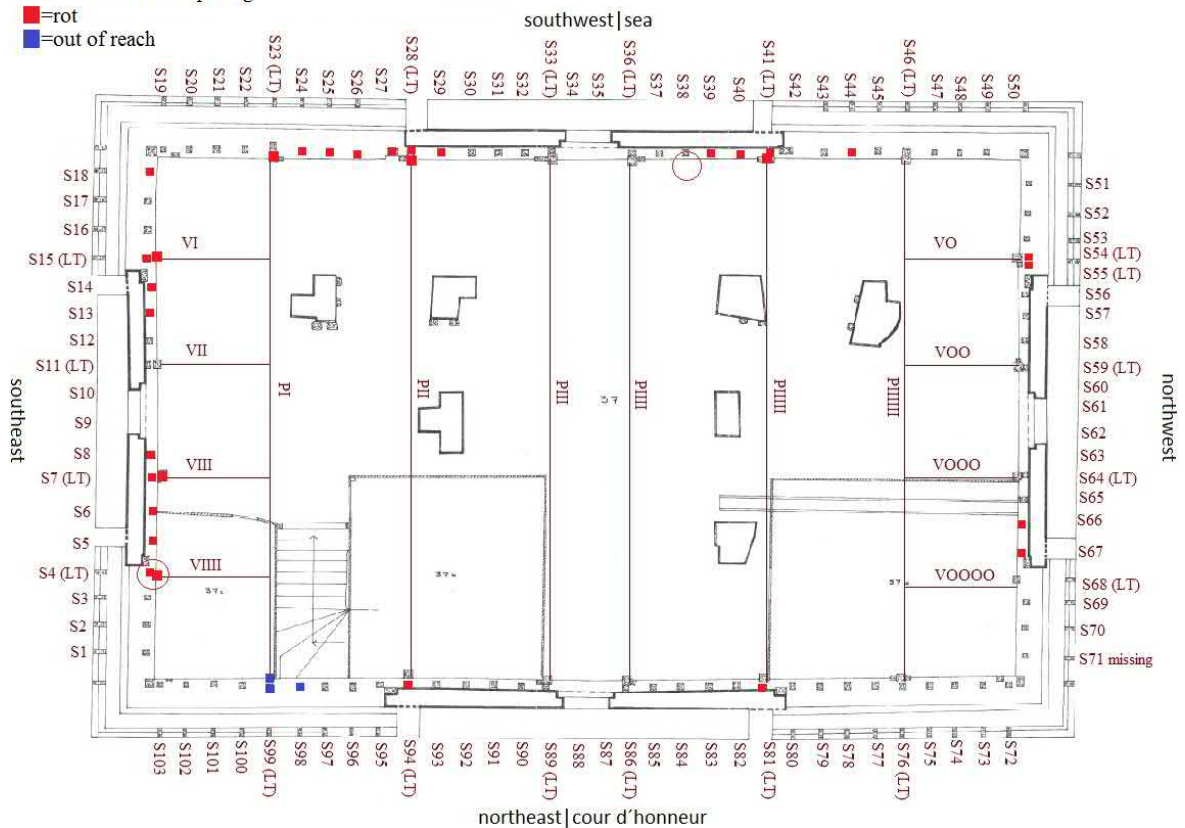
Figure 37. The mapping of rotten timber members in the attic near the floor level based on the visual inspection is shown in the figure with red markings.

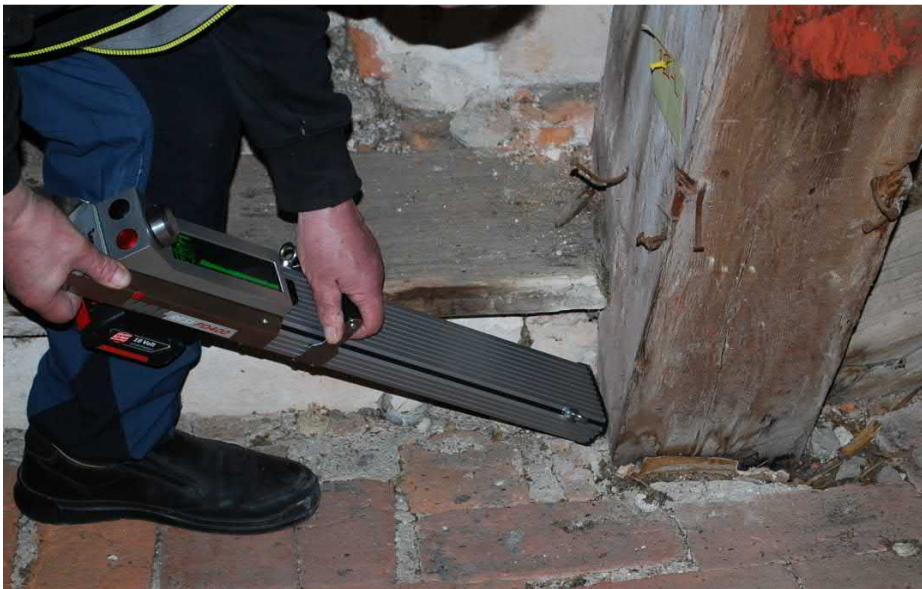
Figure 40. Resistance drilling performed to the post of the leaning trestle (PIIII) on the southwest side of the roof. The figure also shows that birch bark has been used to protect the embedded parts of the post from moisture.

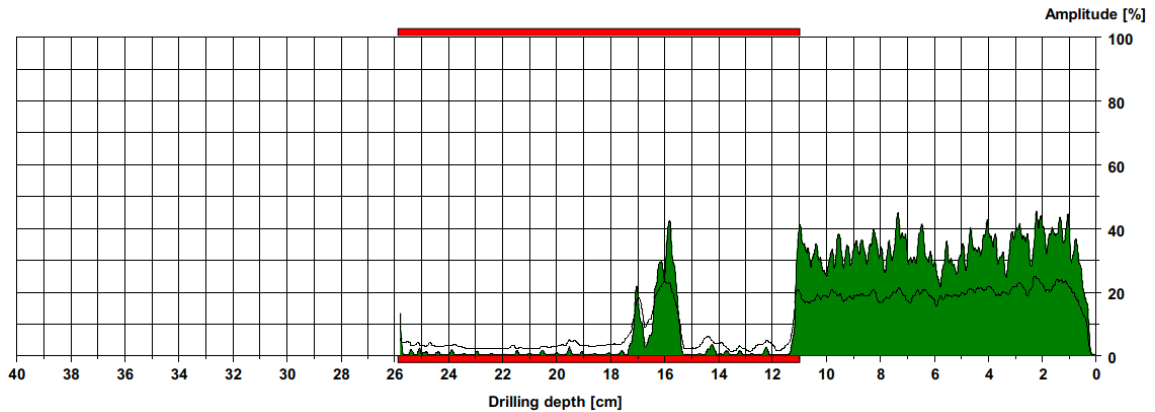
Figure 41. Resistograph profile from tie beam end A36-86L shows clearly that the timber is rotten which can be seen in the drop of resistance drill curve (black) and force feed curve (green area) when the drilling depth reaches 11 cm.

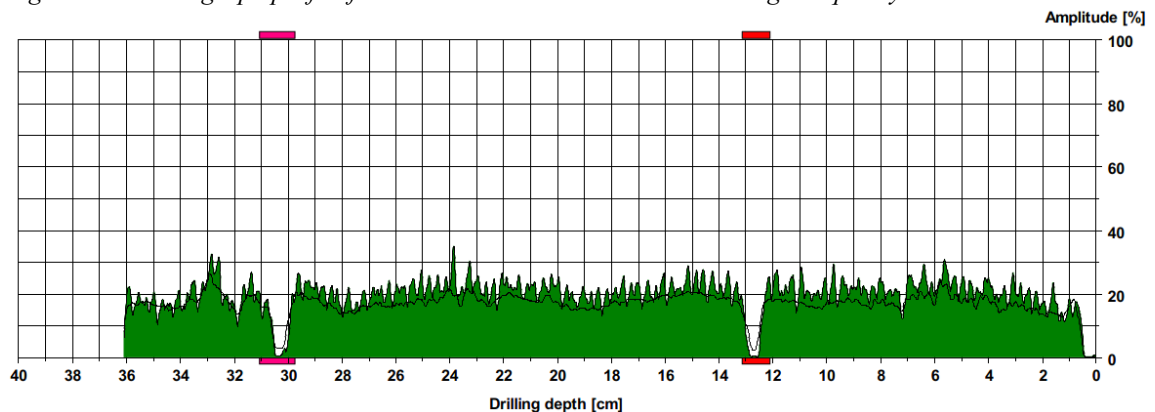
Figure 43. Resistograph profile from the tie beam end A33-89 K shows that the condition of timber can be argued in some drillings.

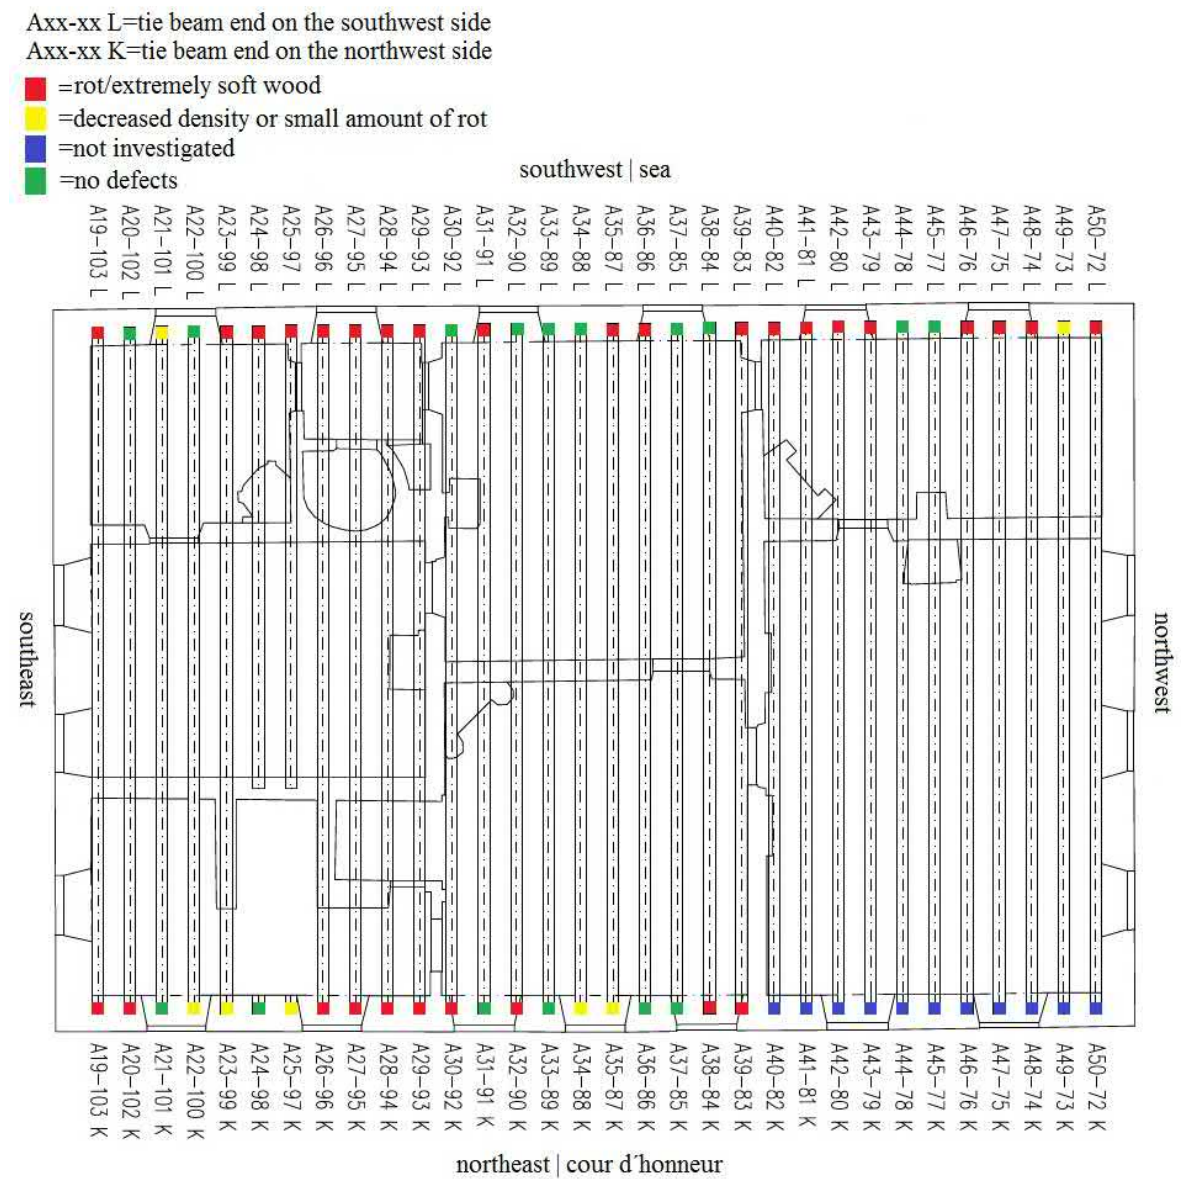
Figure 44. Condition of tie beams ends in the third floor are marked according the resistance drillings.

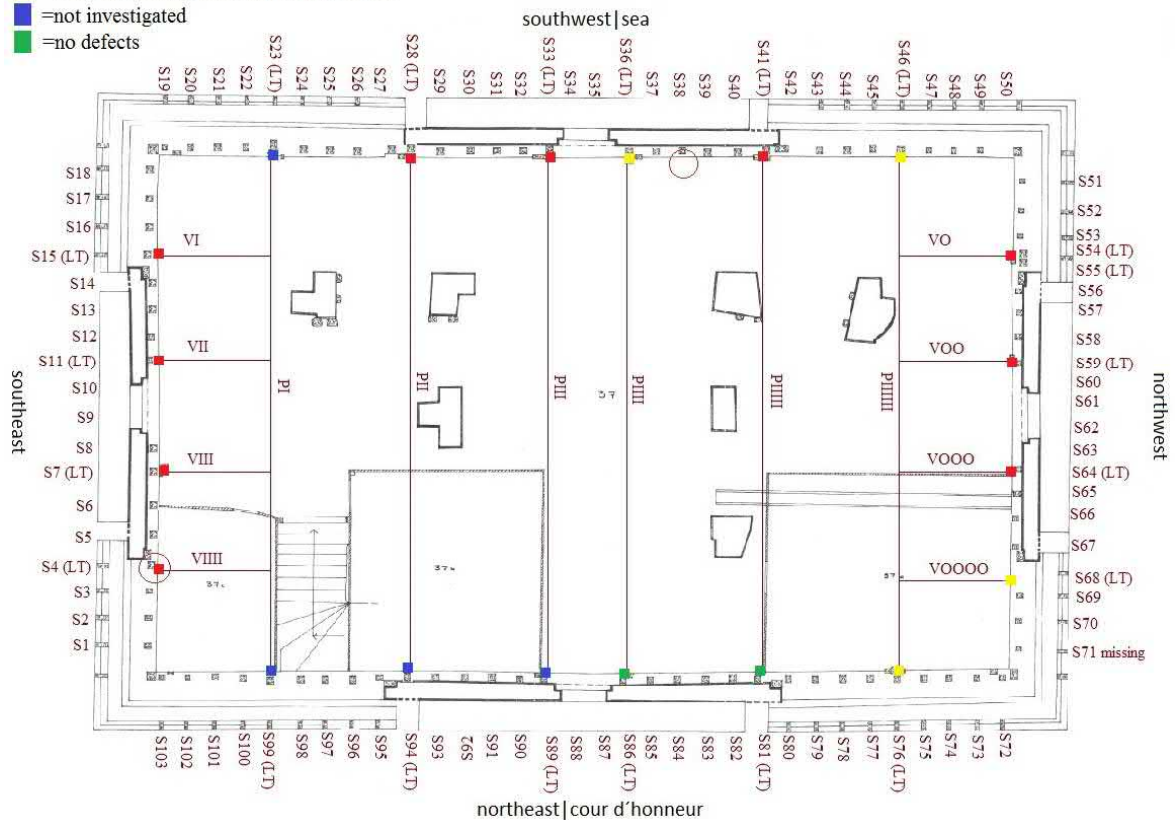
Figure 45. Shows the condition of the posts according to the resistance drillings.

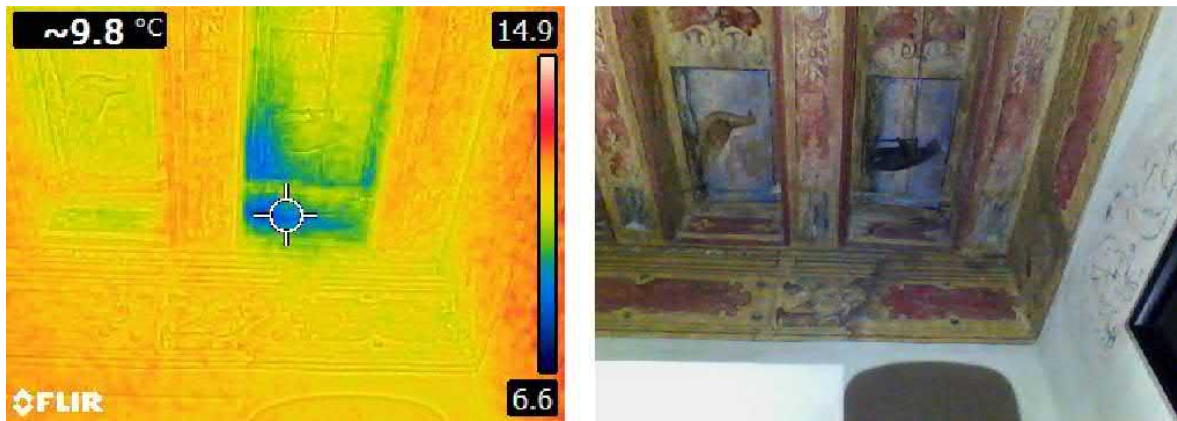
Figure 46. The leaking of cold can be seen in the IRT -image of a spot in the attic where a structural opening has been made.

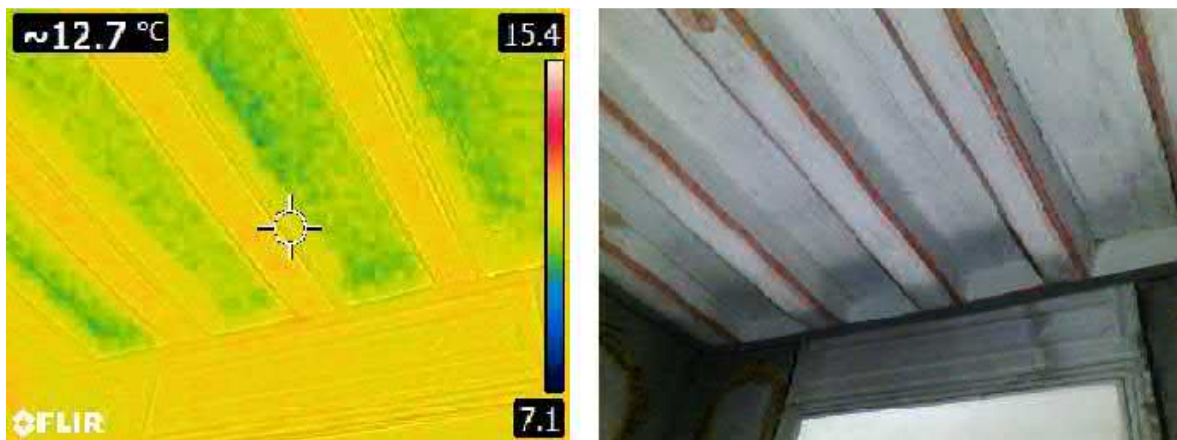
Figure 47. The second tie beam from the left sounded hollow when tapped close to the masonry wall which indicates rot in the beam. However, the infrared thermography showed no increase of cold leaking from outside.

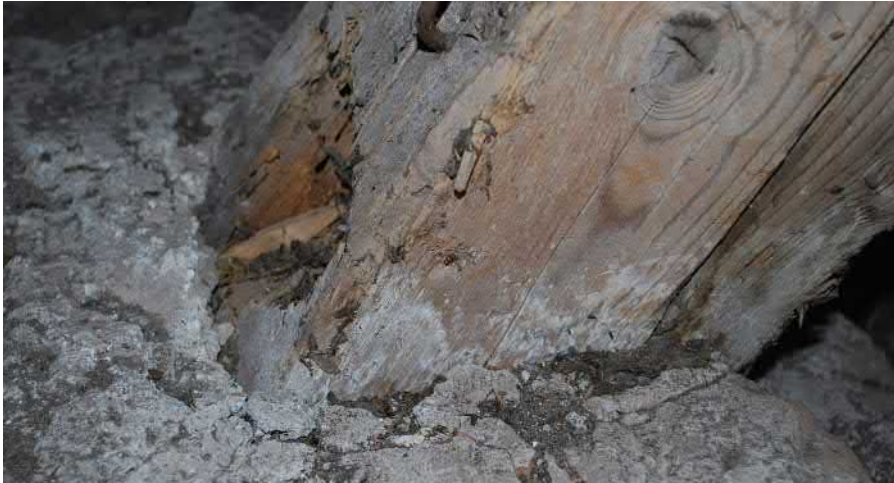
Figure 3. Rotten rafter S18 penetrating to the masonry wall.

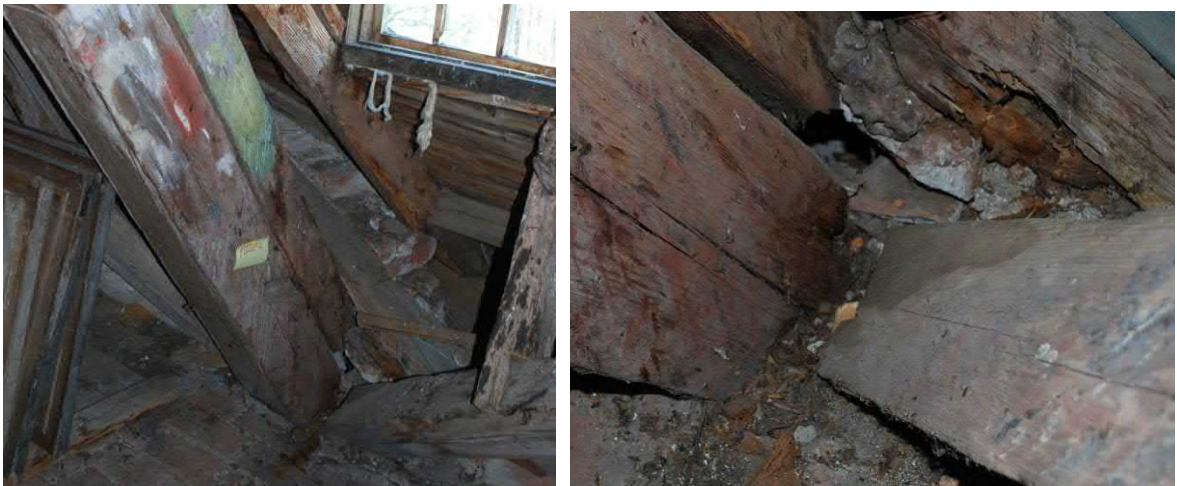
Figure 5. Left: post of the leaning trestle (PIIIII), rafter (S41), cross bracing and the diagonal timber member that reaches to the top of the gable. Right: showing the stage of decay more detailed. Rafter has lost its entire cross section.

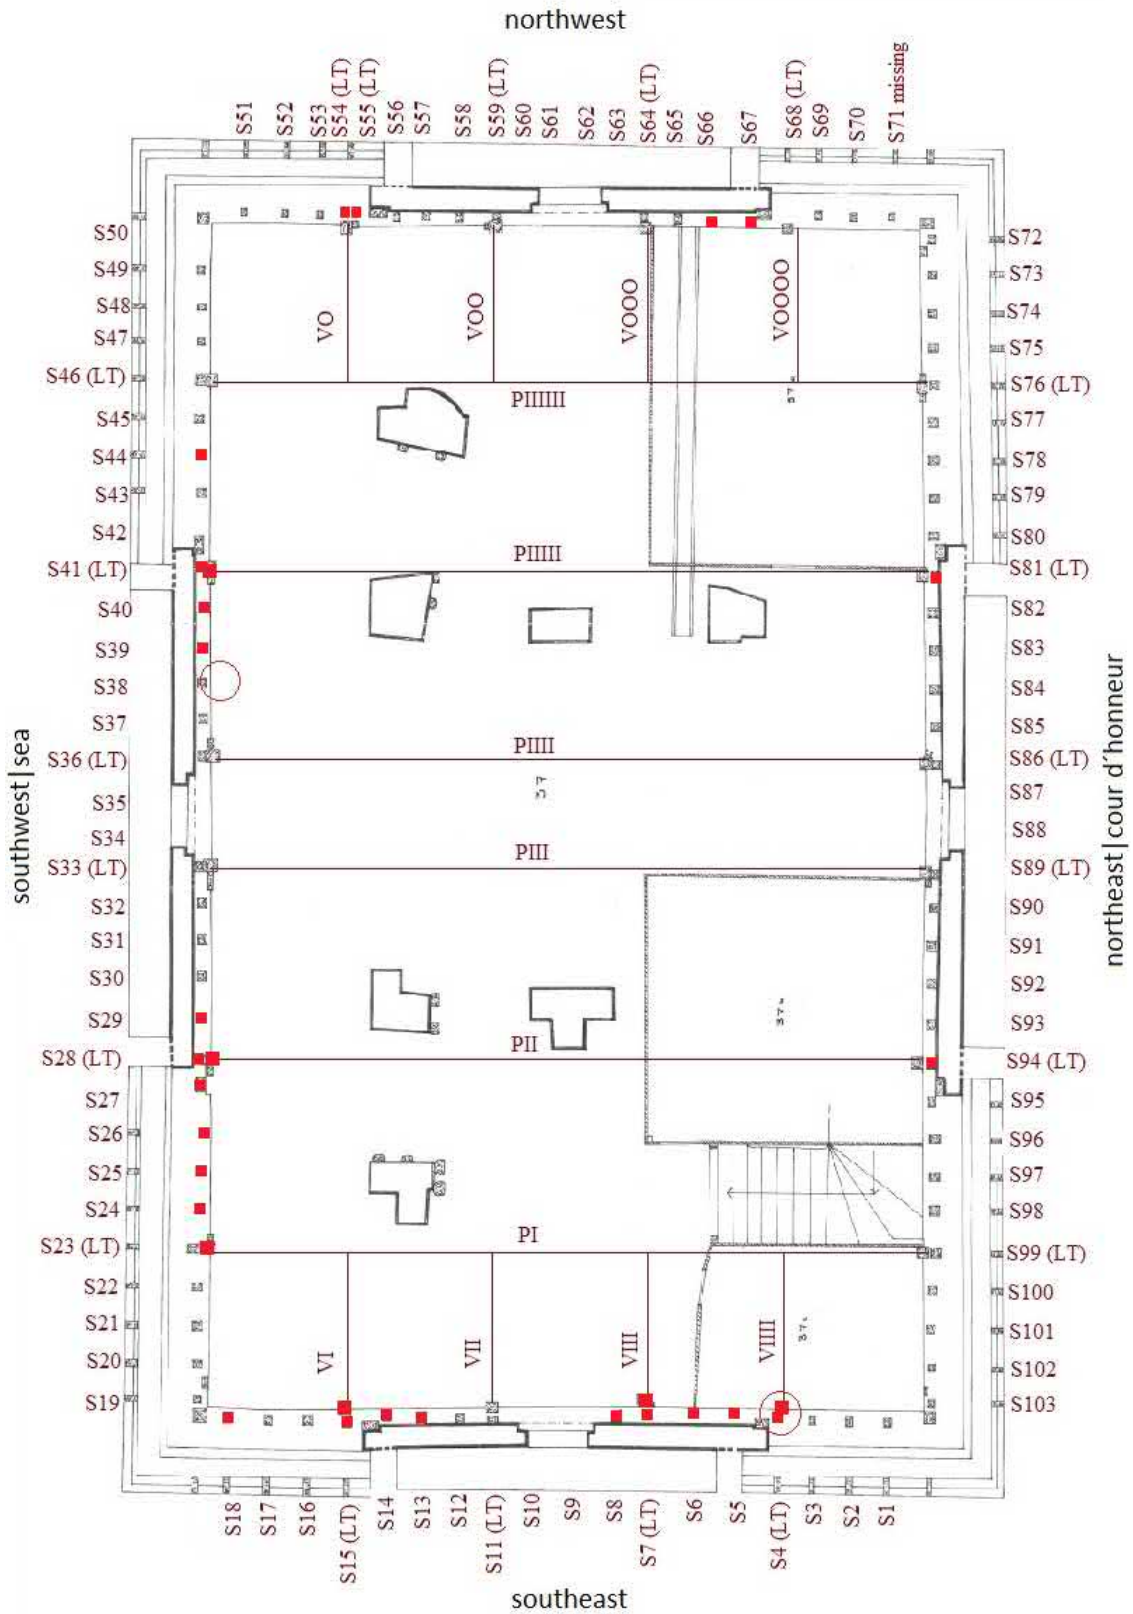
Figure 6. The mapping of rotten timber members (rafters and posts) in the attic near the floor level based on the visual inspection. Rotten members are shown in the figure with red markings.

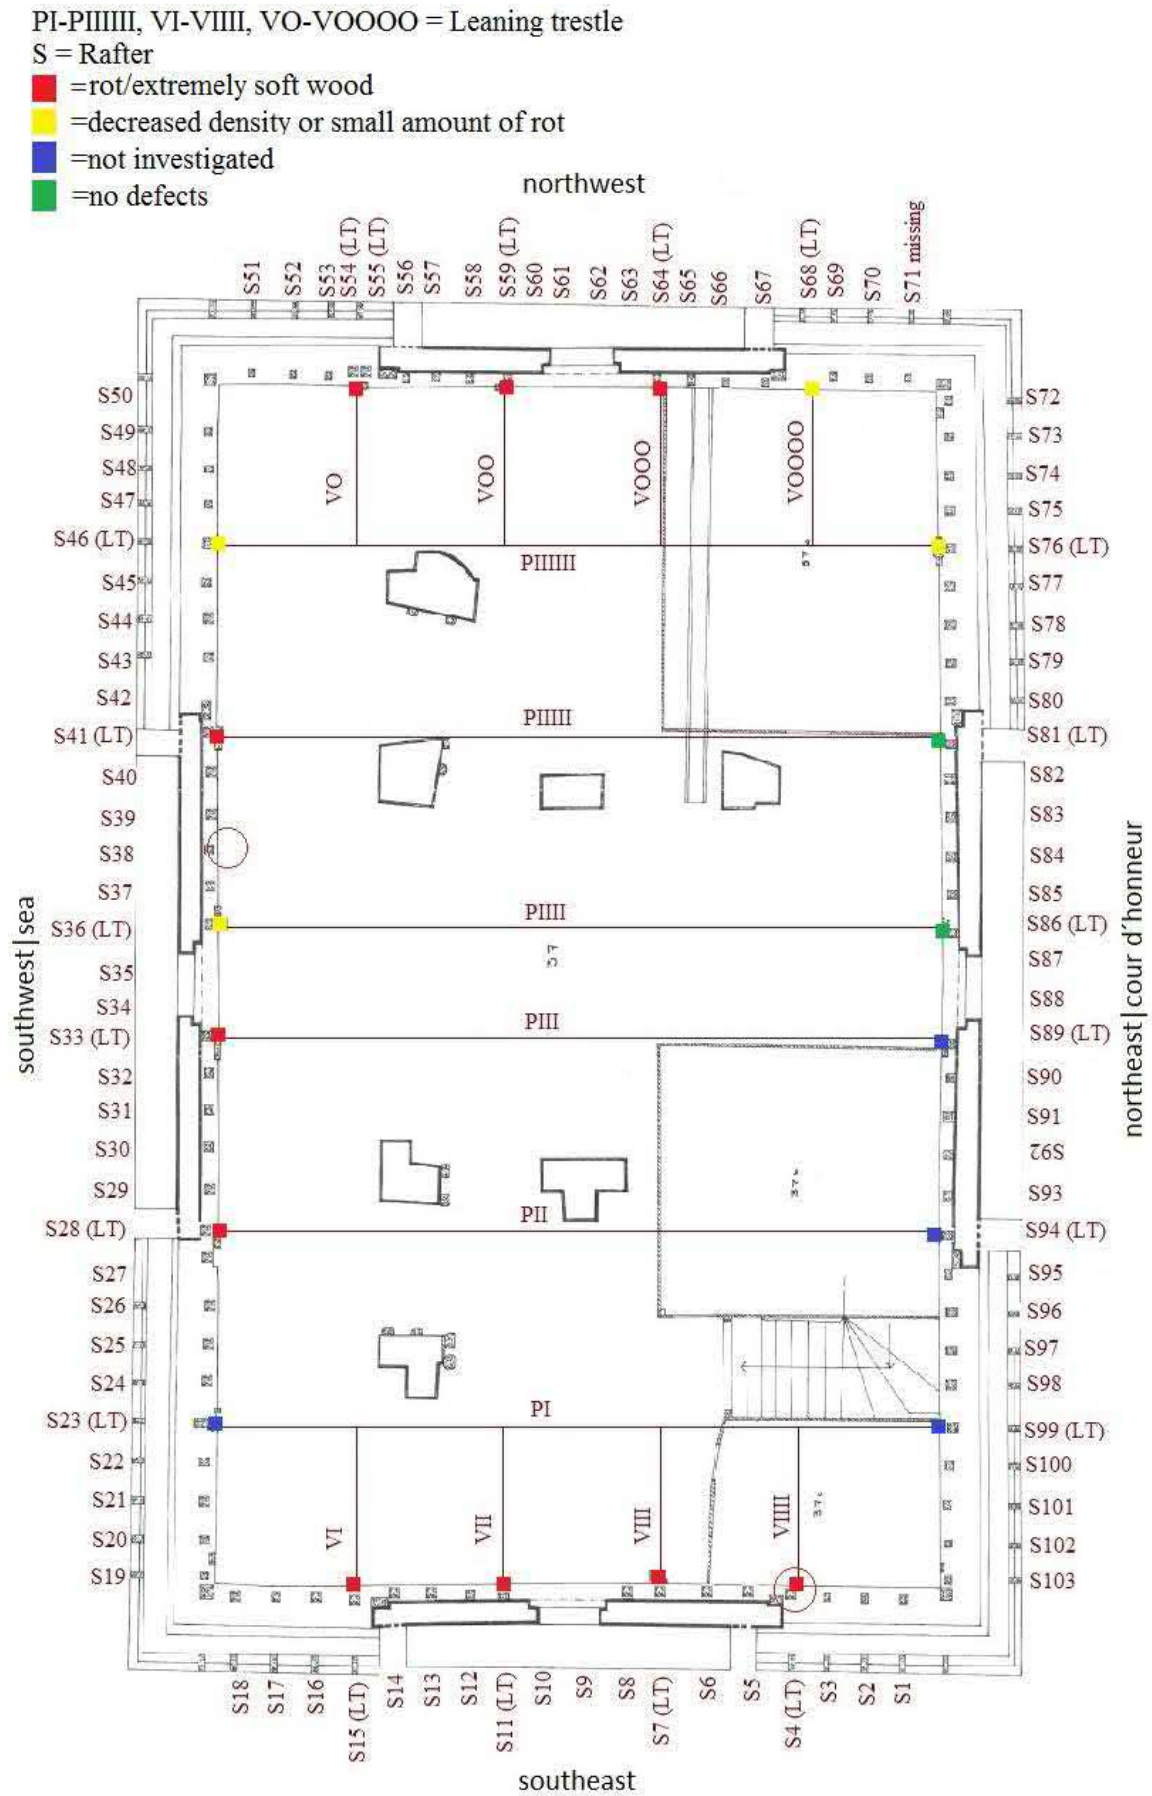
Figure 7. Condition of the posts of leaning trestles according to the resistance drillings.

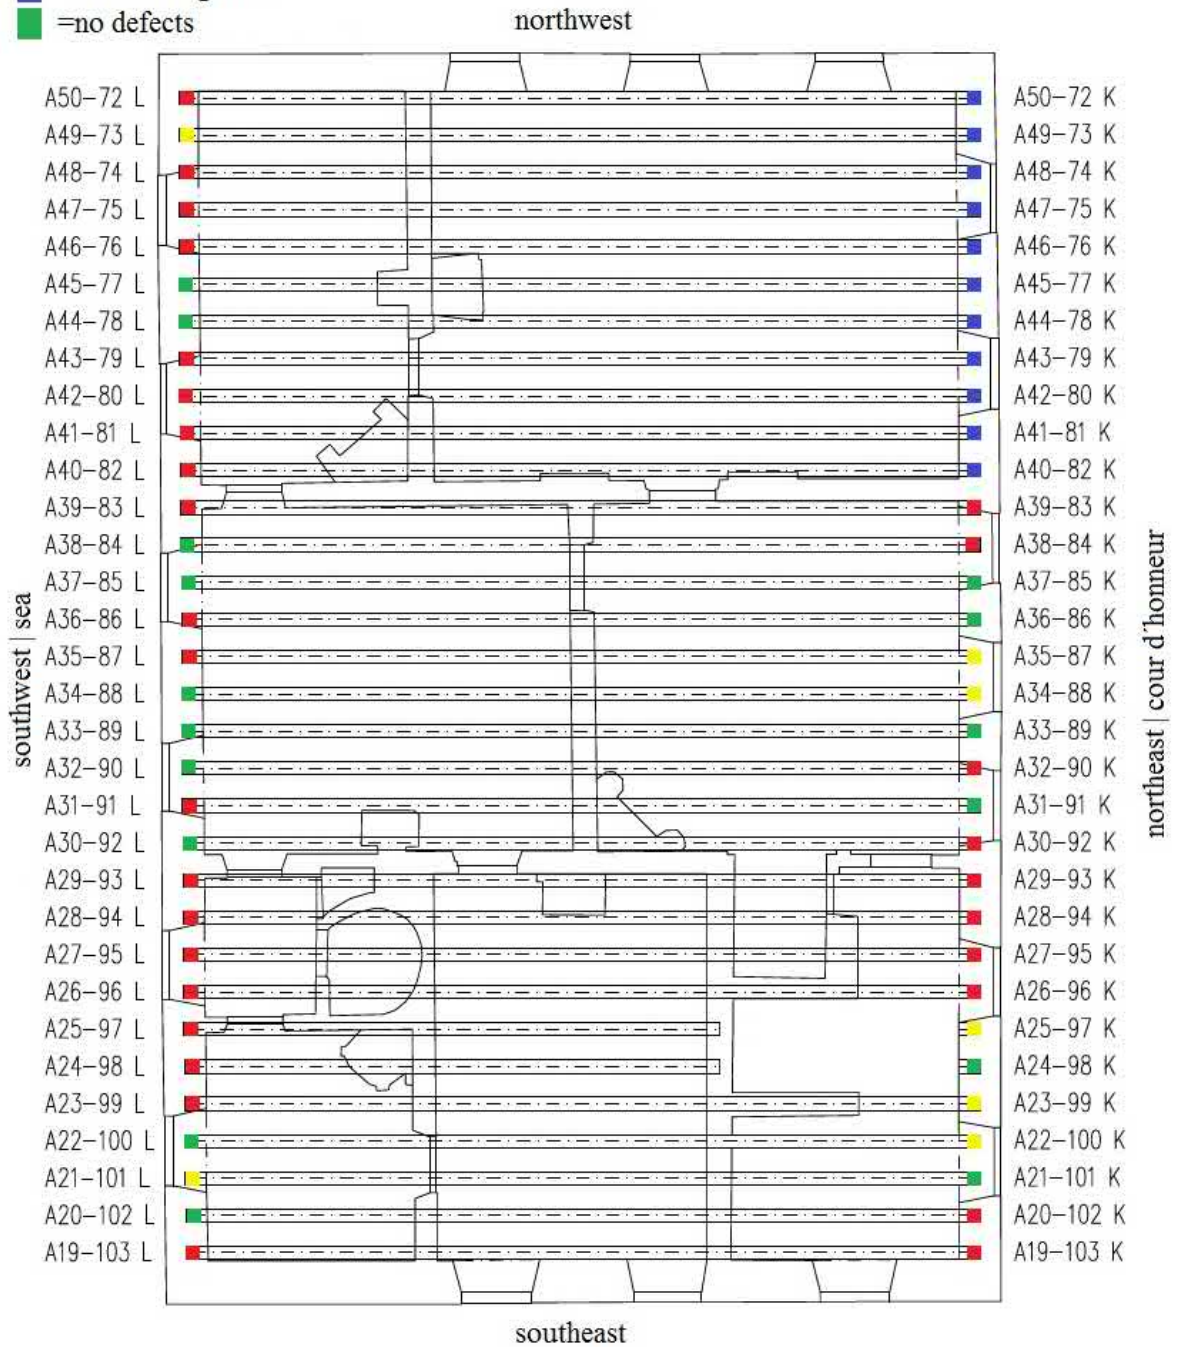
Figure 8. Condition of the tie beam ends in the third floor according the resistance drillings.
