# The history of the mortars of Turku castle

Misa Nurminen, MSc Architecture

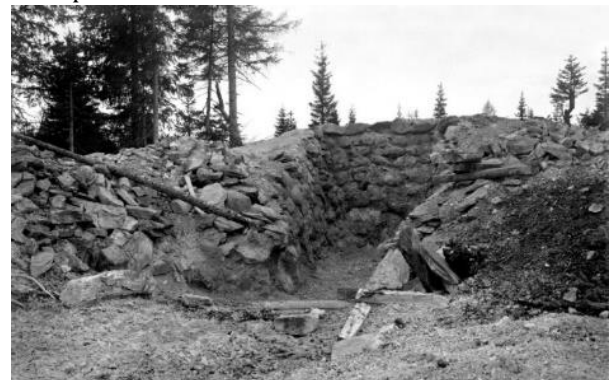
Picture 1: Lime kiln in Kainuu, Finland (Frosterus 1904).

in areas with limestone deposits, which are common in Southwest Finland<sup>9</sup>. Known major lime-burning locations in medieval times were Parainen and Lohja<sup>10</sup>. In addition to location, there is some knowledge of the methods used in lime burning. Lime burning has traditionally been a folk craft in Finland<sup>11</sup>. Peasants burned lime for their own use, for sale, and as a tax to be delivered to the crown<sup>12</sup>. Typically, Finnish peasants used earth kilns for lime burning<sup>13</sup>. An earth kiln is an approximately 8-meter-long and 5-meter-wide pit dug into a hillside, lined with clay and granite. When loading limestone into the kiln, vault-like channels are left between the rocks, into which whole tree trunks are inserted for burning. Filling the kiln usually took 10–12 days, and the actual burning process lasted 6–7 days. For the first few days, the kiln burned openly, after which its top was closed for the remainder of the time to retain heat. One medium-sized kiln produced approximately 70,000–80,000 litres of lime at a time. In the busiest kilns, lime burning was performed six or seven times a year.<sup>14</sup> However, there was considerable variation in kiln construction and burning times depending on the location<sup>15</sup>. This description is therefore approximate. Figure 3 shows an example of a Finnish earth kiln.

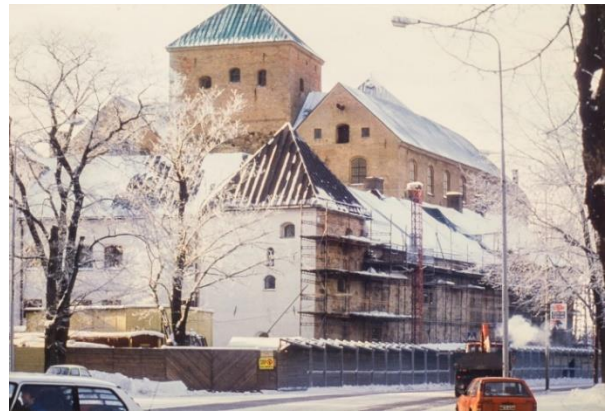
Picture 2: The bailey gets a new plastering (Kotkas 1985).

In later repairs, various types of mortars have been experimented with and used in the castle. For instance, in the construction site protocol from 1979, it is mentioned that interior walls were repaired with masonry cement, and the patched areas were covered with lime and clay plaster<sup>59</sup>. In 1980, plastering was done using lime-cement mortar, and the surface layer was finished with clay plaster<sup>60</sup>. In 1980s, the facades of the bailey were plastered with lime-cement mortar (Picture 2)<sup>61</sup>.
