Restoration of Load-Bearing Timber Members Subjected to Fungal Growth: A Case Study of Louhisaari Manor's Roof Truss Structure

Master's thesis submitted for evaluation in order to finalize master's degree in Building Technology.

Espoo, 21st of September, 2019

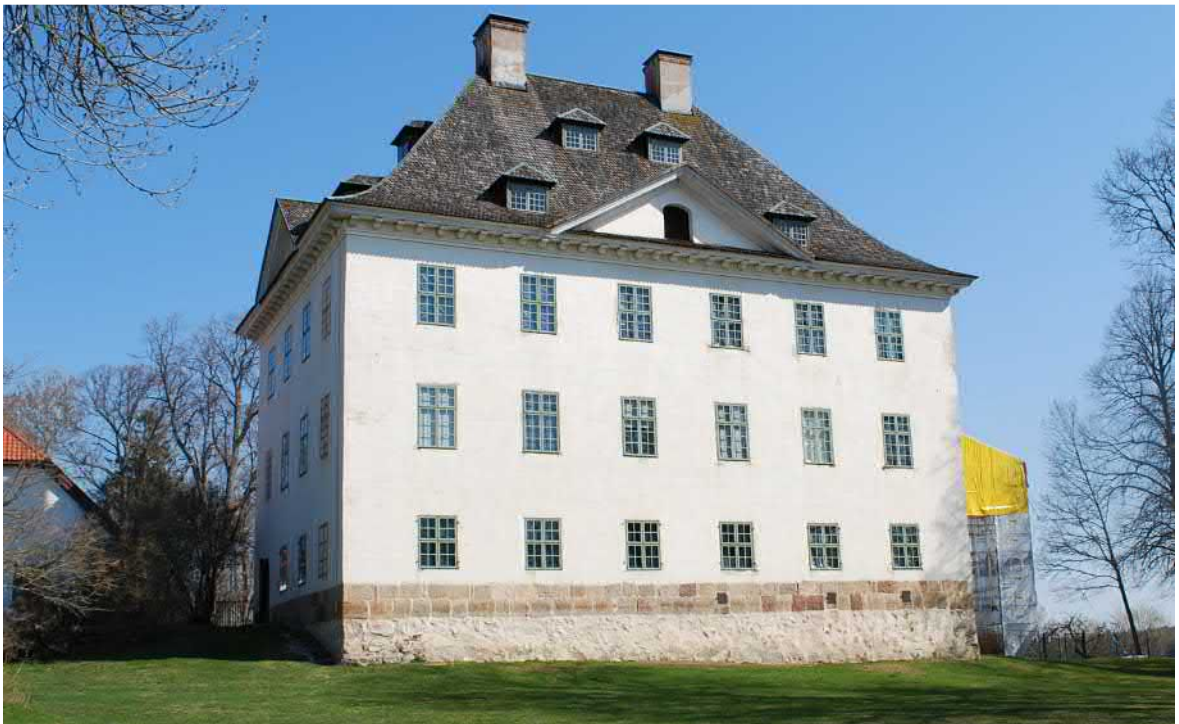
Figure 16. Louhisaari manor. The longer side shown in the figure is facing the sea (southwest).

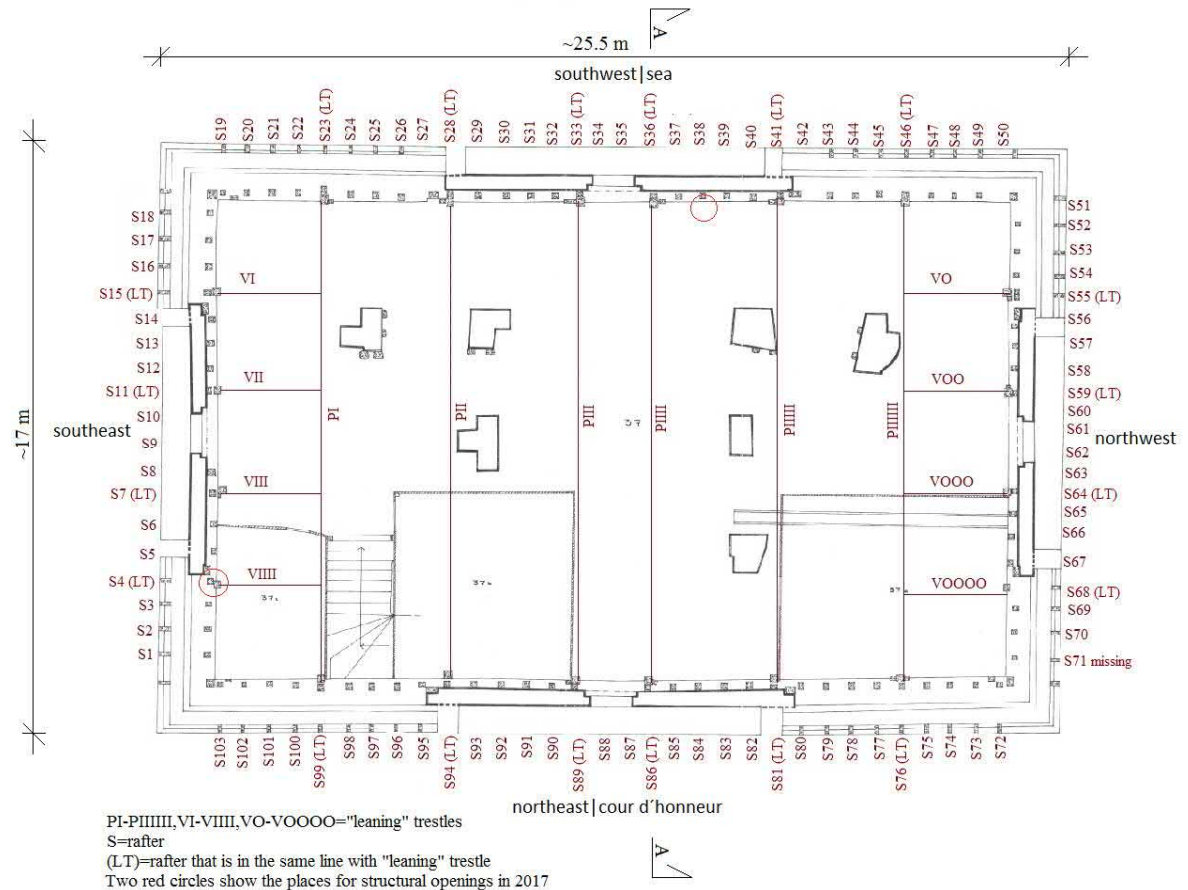
Figure 17. The markings that are used for the leaning trestles and rafters in the floor plan drawing of the attic.

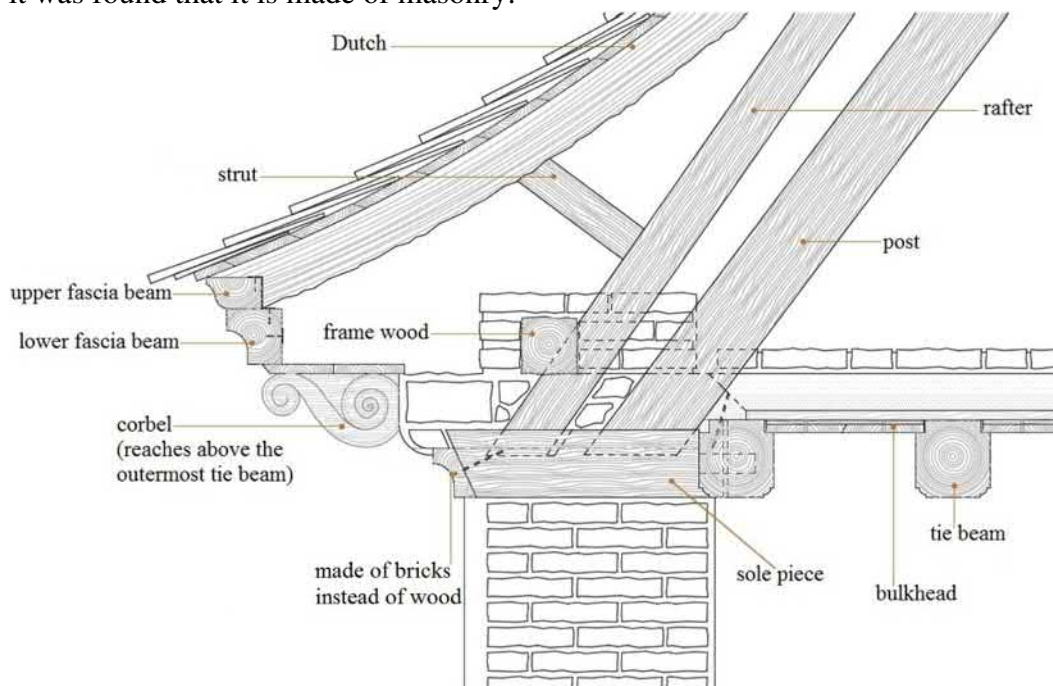
Figure 19. Elevation from the eave structure in the shorter side of the roof. Adapted from the original figure. [1, p. 104] The previous inspection assumed that the batten is made of timber, but it was found that the whole façade is made of bricks.

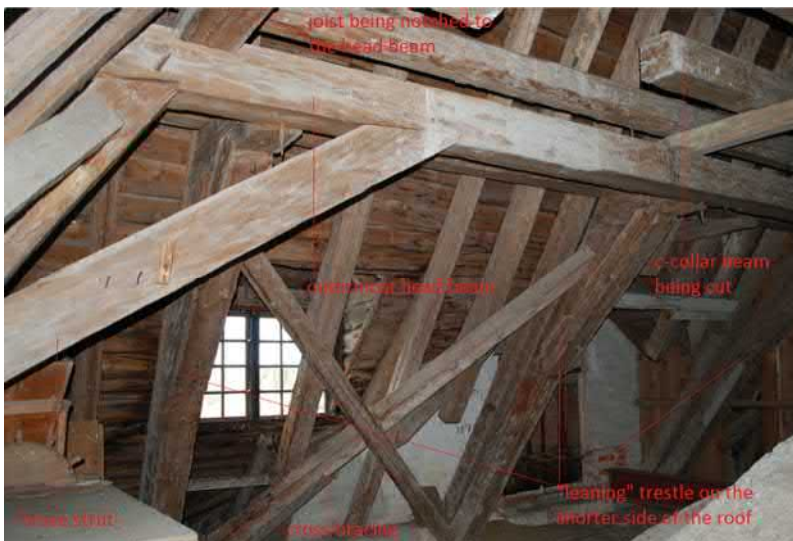
Figure 21. The outermost leaning trestle which spans across between the long external walls is supporting the leaning trestles on the shorter side. Cross bracings can be seen between leaning trestles. The cross bracings are missing where the gables are located. One of the collar beams have been cut due to previous lead through.

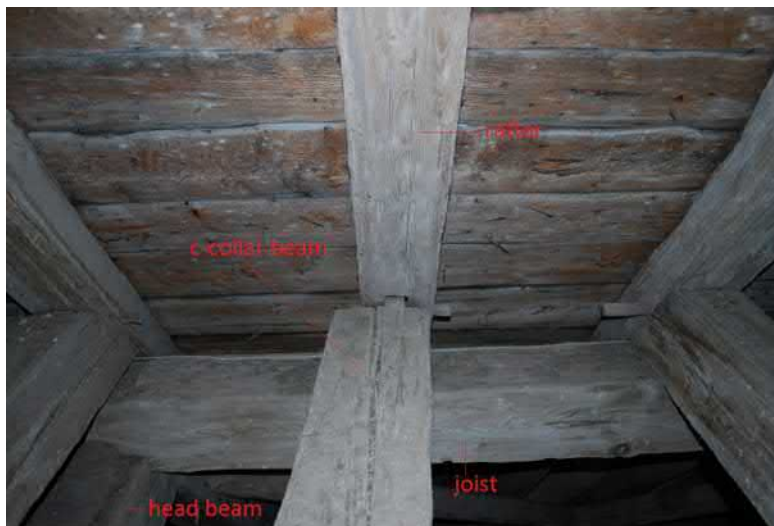
Figure 22. Notched joist lying above the head beam. C-collar beam and the rafter is connected with doweled mortise and tenon joint. See detail A in figure 18.

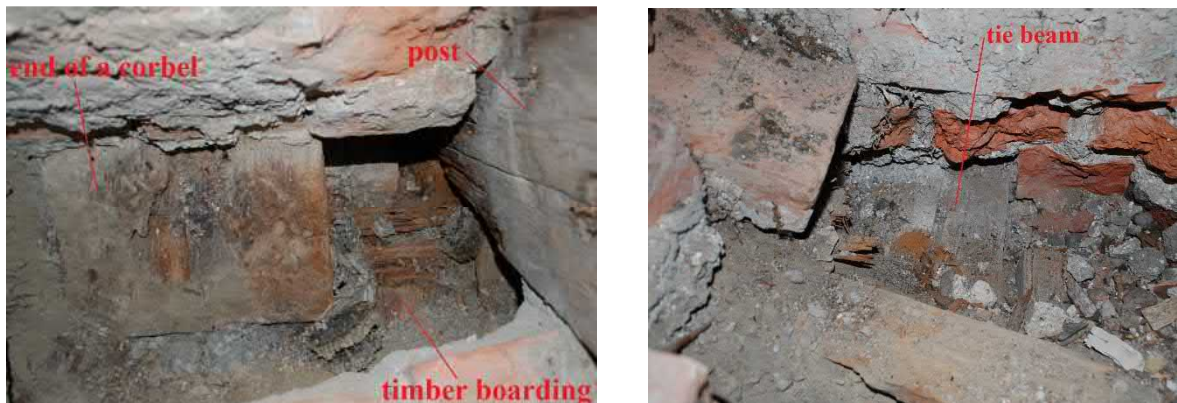
Two structural openings (places marked with a circle in the Figure 37) have been made in the attic during previous inspections to points which had already been damaged due to water leakage and seemed to have been opened earlier also [1, p. 119]. Structural openings show rotten wood inside the masonry wall as can be seen from Figure 32.

Figure 32. Structural openings that have been made in the attic. The left one is in the southeast and the right in the southwest side of the roof.

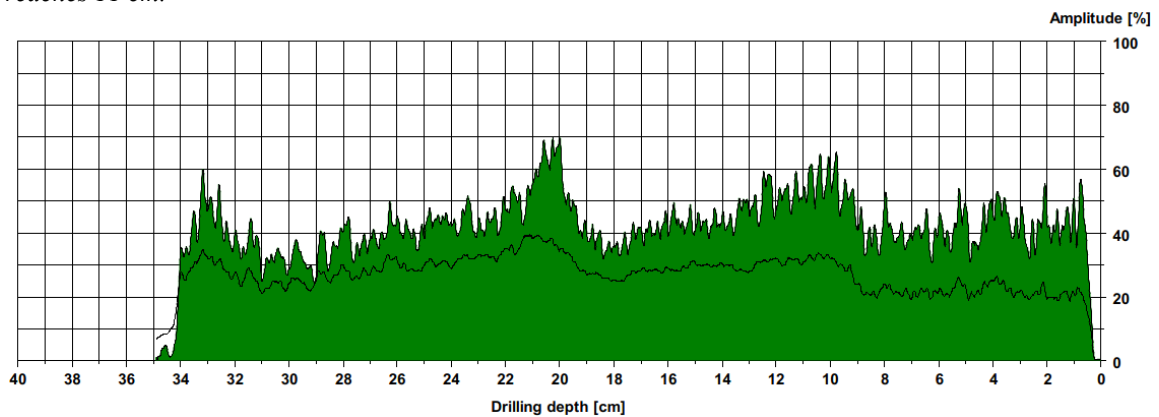
Figure 42. Resistograph profile from the tie beam end A44-78 L shows good quality timber.

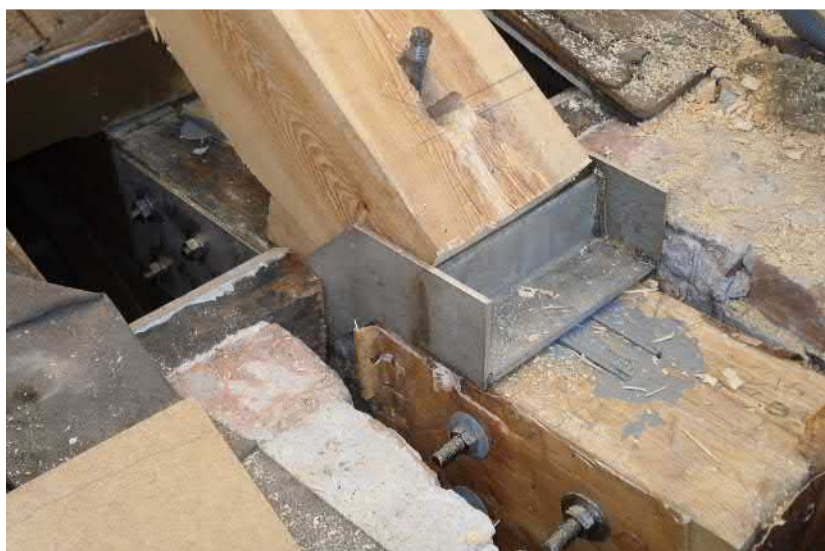
Figure 49. Repair of a tie beam end in 2010 in the catholic church located in Helsinki. The rotten end of the tie beam supported by masonry wall was replaced with a new timber piece and the connection between members was implemented with steel plates and bolts. Birch bark was installed to the surfaces of timber member, and air gaps surrounding the member were left to improve the durability of the structure. [55]

order to improve the durability of the repair and circulation of air. Figure 49 shows an example of a repair where free space has been left to improve air circulation, and the timber surface has been protected with birch bark.
